USDA FOREST SERVICE
RESEARCH PAPER INT-97
1971

INVESTIGATION OF SLOPE FAILURES IN THE IDAHO BATHOLITH

M. J. Gonsior and R. B. Gardner

INTERMOUNTAIN FOREST AND RANGE EXPERIMENT STATION
Ogden, Utah 84401

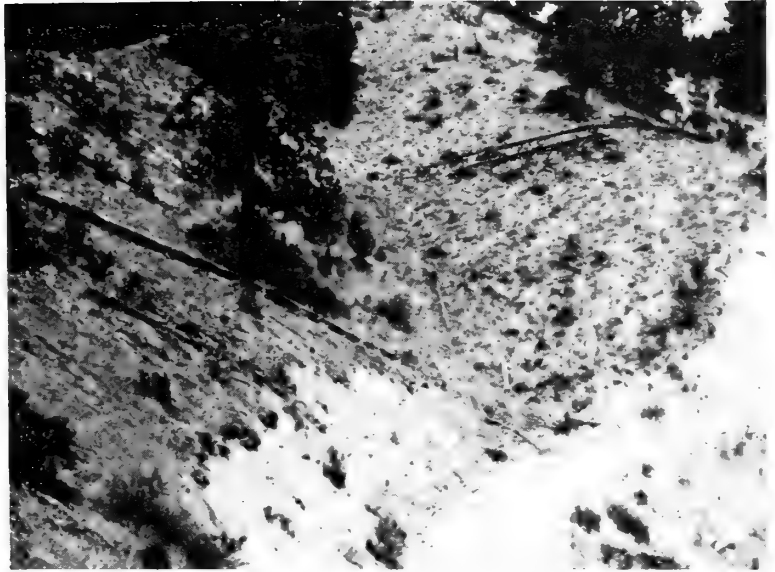
Figure 13.--This illustrates proximity of site 917-1 to ridgetop.

Site 917-1. As shown in figures 13 and 14, this site is a stable embankment crossing a small gully on Road 917 and is located approximately 1.7 miles from the junction of Road 917 and the main Secesh Road (fig. 4). A plan view and three profiles are shown in figure 15.

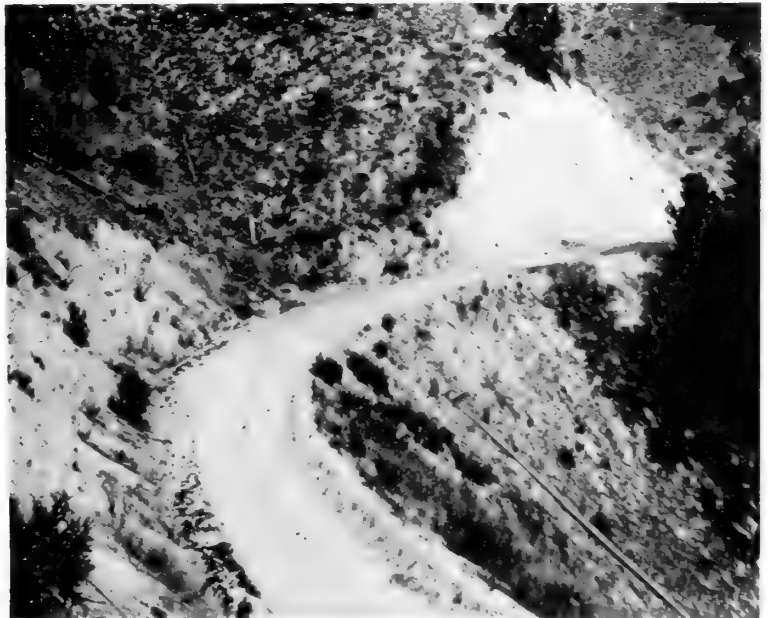
Provisions for surface drainage seem to be adequate at this site. A culvert has been properly installed in the embankment with a suitable downspout and wire mesh catchment to dissipate the hydraulic energy. The close proximity of the site to a ridgetop can be seen in figure 13, illustrating the relatively small drainage area contributing to the culvert flow. The road has a 9 percent favorable grade at this location and a similar embankment with drainage equally well provided for is located only about 100 yards up the road (east) from this site. Therefore, surface water flowing down the road does not present a drainage problem at site 917-1. A soil-cement berm, which can be seen in figure 14, prevents road-surface water from eroding the outside slope of the embankment.

Figure 14.--This illustrates berm and culvert downspouts for proper handling of water at site 917-1.

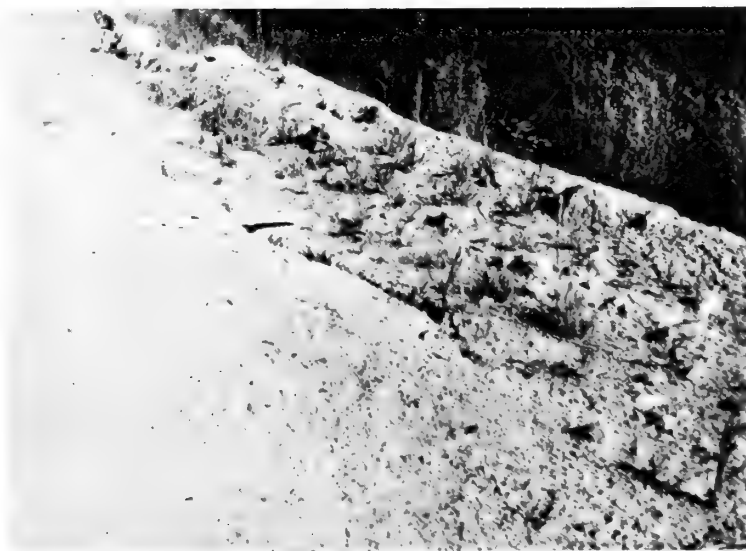
Figure 21.--Evidence of incipient failure at site 917-3, cracking and settlement of fill.

Site 917-3. This site, shown in figures 21-23, is located on Road 917 approximately 4.2 miles from the junction of Road 917 and the main Secesh Road (fig. 4). Considerable importance is placed upon the analysis of this site, primarily because failure is impending, as evidenced by cracking in the road surface and settlement of the outside portion of part of the fill (figs. 21 and 22). In addition, a narrow portion of the fill has failed, as shown in figure 23. Thus, this site offered the best opportunity for material sampling and definition of the mode and shape of failure.

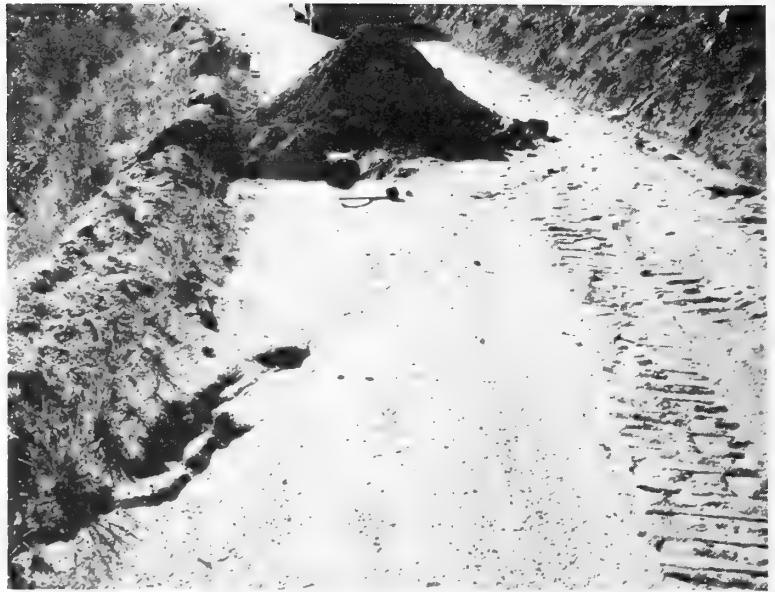
Figure 22.--Additional evidence of incipient failure, site 917-3 (test pit excavation shown in top of photo).

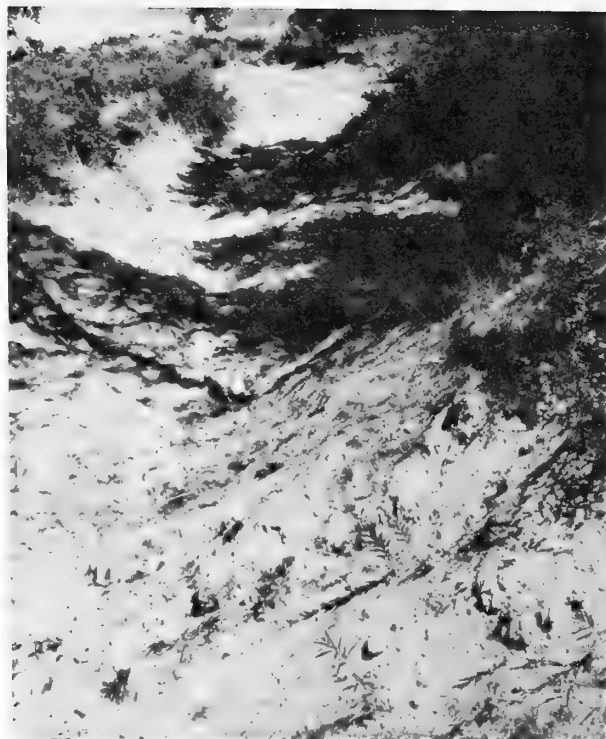
Site 917H-3. This site is a relatively long, narrow failure of material lying in a swale above Road 917H at a location within 100 yards of site 917H-2. It is pictured in figures 26 and 27, as viewed from the bottom and top of the failure, respectively.

Figure 26.--View from below site 917H-3, illustrating its long, narrow, and shallow characteristics.

Although the road cut intersected the bottom of the swale, it is difficult to state with certainty that this resulted in sufficient loss of support to cause failure. By using appropriate techniques for the analysis of stability of a cohesive, infinite slope, it is apparent that the natural slope might have failed in the absence of road construction. Such an analysis follows:

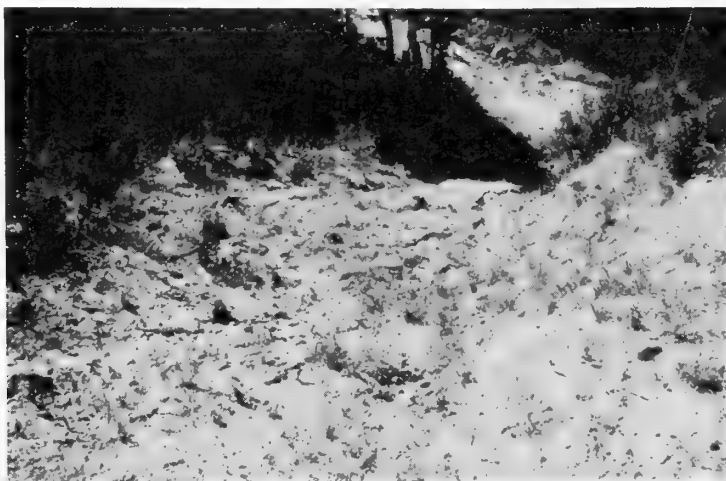
Figure 27.--View from above site 917H-3, illustrating road at bottom.
